# dahl-beck electric

## Metal Spray Services

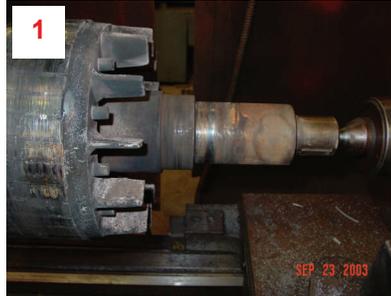
1. Before repairs can begin the motor rotor is placed into a lathe and run-outs are "dialed in". In this case there was a catastrophic bearing failure on the coupling side and the rotor dropped into the stator laminations.

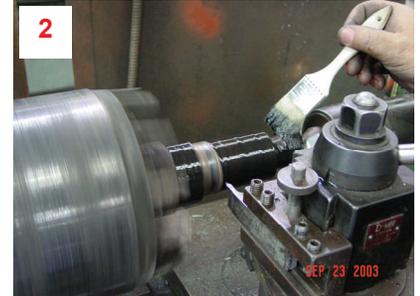
2. Application of the Sulzer Metco Anti-Bond protects these surfaces from being coated with the powder.
3. Heating of the Anti-Bond cures it and keeps it in place.

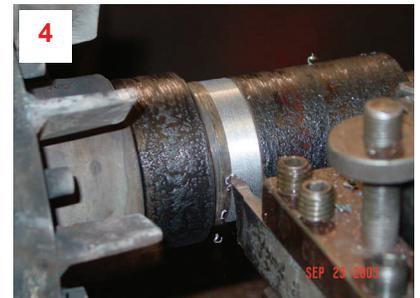
4. Machining of the bearing journal area to be metal sprayed ensures a true surface.
5. Spray application of the composite powder is used to build up the damaged bearing journal.

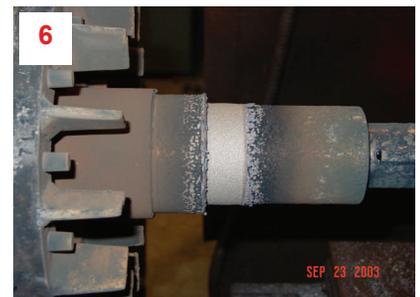
6. This is what the bearing journal looks like after the powder has been applied.
7. Cleaning of adjacent areas with emery cloth.
8. Spray painting of the rotor using red insulating enamel.

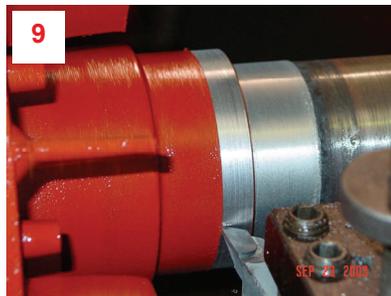
9. Initial machining of the bearing journal and a true surface for the balance machine rollers are cut at this time.
10. Final cleaning of all areas with emery cloth before the rotor is sent to be balanced.
